**REBUILD ATLANTA  
ENERGY AUDITOR'S REPORT  
SOLID WASTE SERVICES: LIDDELL SUBSTATION**

Prepared: June 23, 2004

### **Liddell Substation 1540 Northside Drive Atlanta, Georgia 30318**

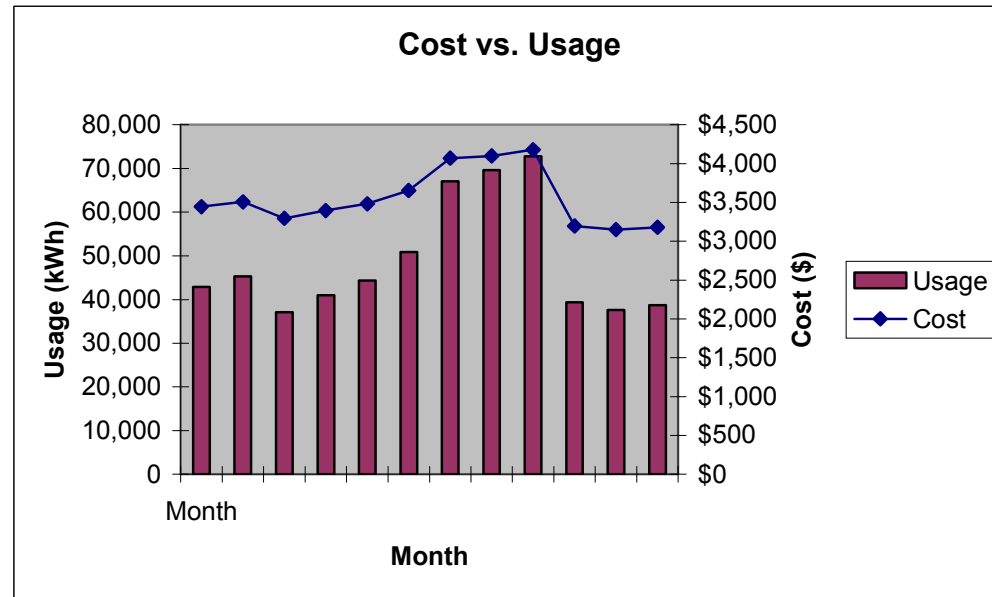
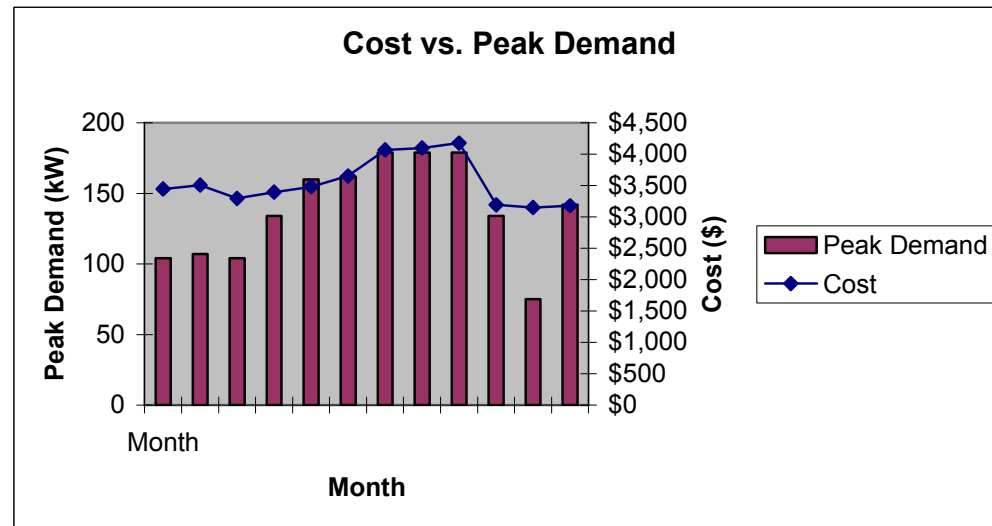
Month	kWh	Peak kW	Cost
Jan-03	42,880	104	\$3,445
Feb-03	45,280	107	\$3,507
Mar-03	37,120	104	\$3,296
Apr-03	40,960	134	\$3,396
May-03	44,320	160	\$3,482
Jun-03	50,880	162	\$3,652
Jul-03	67,040	179	\$4,069
Aug-03	69,600	179	\$4,099
Sep-03	72,800	179	\$4,179
Oct-03	39,360	134	\$3,195
Nov-03	37,600	75	\$3,150
Dec-03	38,720	142	\$3,179
<b>Total</b>	<b>586,560</b>	<b>N/A</b>	<b>\$42,649</b>

Additionally, since major recommendations in this facility offer the potential to reduce natural gas usage, natural gas consumption and cost are provided as well.

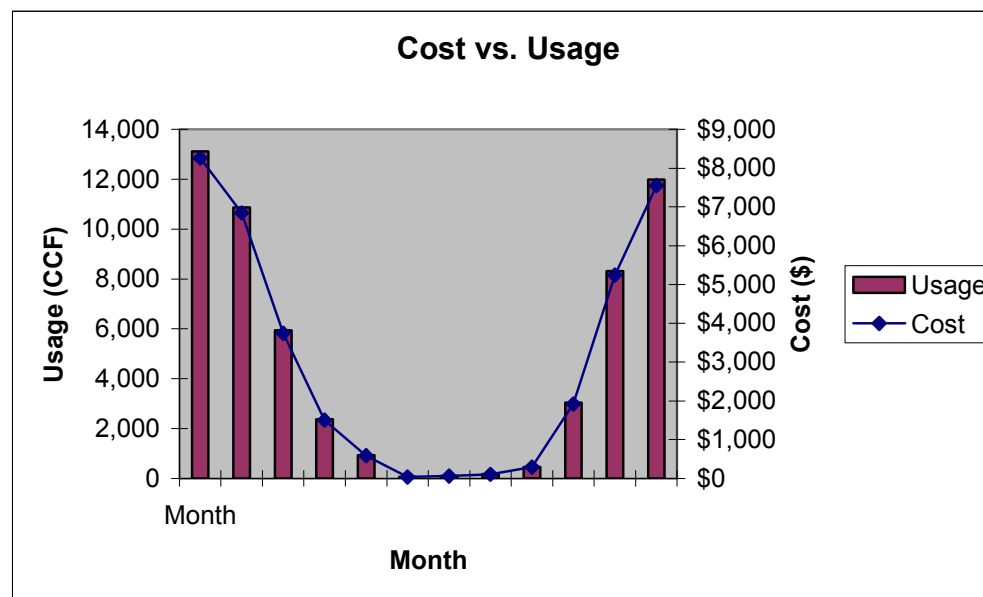
Month	CCF	Cost
Jan-02	13,115	\$8,262
Feb-02	10,868	\$6,847
Mar-02	5,945	\$3,745
Apr-02	2,377	\$1,498
May-02	932	\$587
Jun-02	59	\$37
Jul-02	94	\$59
Aug-02	168	\$106
Sep-02	466	\$294
Oct-02	3,043	\$1,917
Nov-02	8,317	\$5,240
Dec-02	11,987	\$7,552
<b>Total</b>	<b>57,371</b>	<b>\$36,144</b>
